Observing the significance and benefits of oil performance in reducing engine coking in CFM56-5B engines

Customer	Juneyao Airlines
Location	Shanghai, China
Industry	Commercial airline
Website	www.juneyaoair.com/en
Customer evaluation	Engine disassembly and inspection took place at repair and overhaul facility. Engine has more than 30,000 hours and 15,000 cycles using Eastman Turbo Oil 2197™.
Highlights	<ul style="list-style-type: none"> • Using Eastman turbo oil since EIS in December 2006 • 30,312:51 hours • 15,080 cycles
Contact	TurboOil@eastman.com

Juneyao Airlines elected to perform the oil systems review on a CFM56-5B4/P engine from an A320-200 aircraft. The engine was removed and sent to General Electric's Strother, Kansas, repair and overhaul facility for disassembly, inspection, and overhaul.

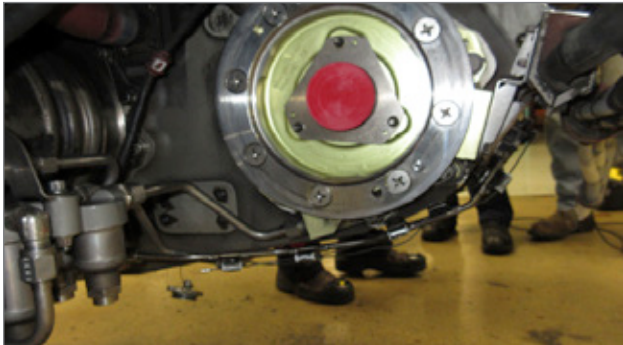
ATS drive pad

All line-replaceable units (LRUs) were removed from the AGB with the exception of the fuel control unit (FCU), and the exposed drive pads showed no evidence of oil leakage.

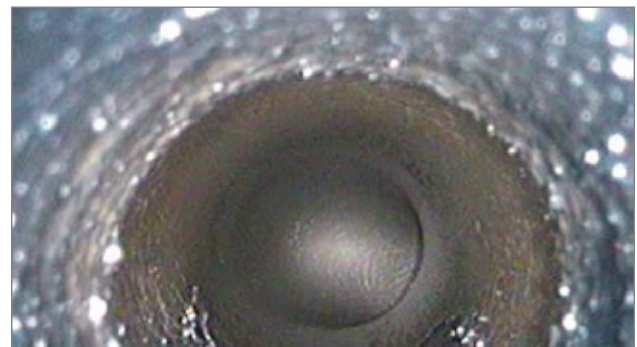
The supply tube inspection was documented through a borescope video that is available for review. Despite 30,312 hours and 15,080 cycles on the engine, the supply tube borescope showed a very minor buildup of deposits in this pressure tube and only a small amount of varnishing. The tube was estimated to be at least 98% open.

Typically the #5 oil supply tube suffers coking predominately in the area around the elbow and locating flange due to heat conduction from the TRF.

Supply tube view from the locating flange area towards the elbow transition

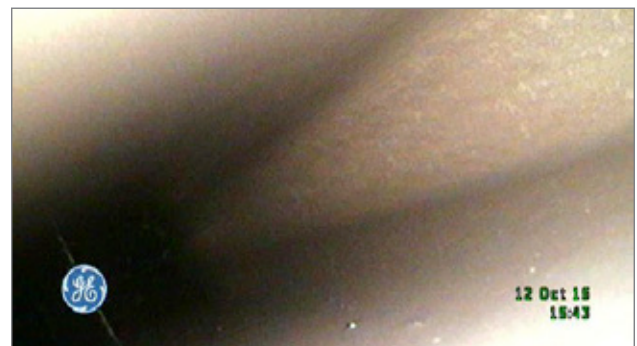
Metal clean scavenge tube

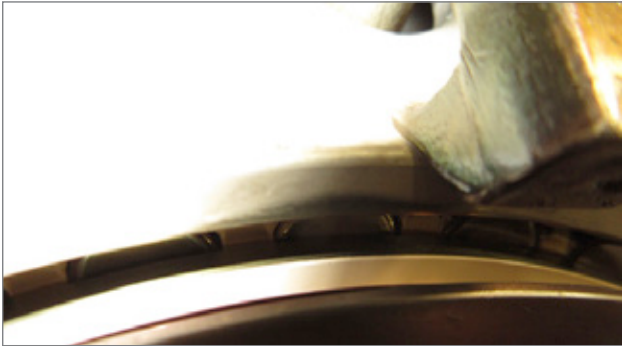
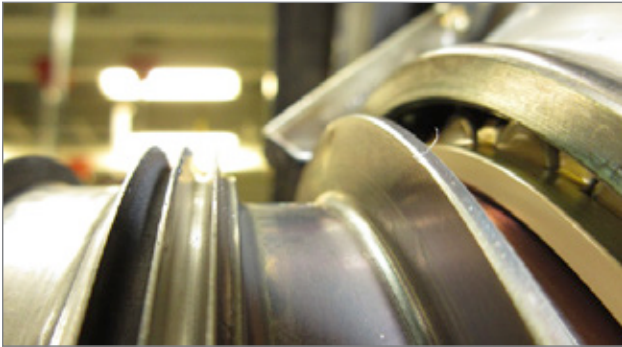
Bearing #3

During the engine disassembly process, there was minimal entry to #3 bearing; however, the visible portions, including the bearings, races, and compartments were very clean.

The inspectors had minimal access to bearing #3; however, what was exposed was very clean, as evidenced in the following images.

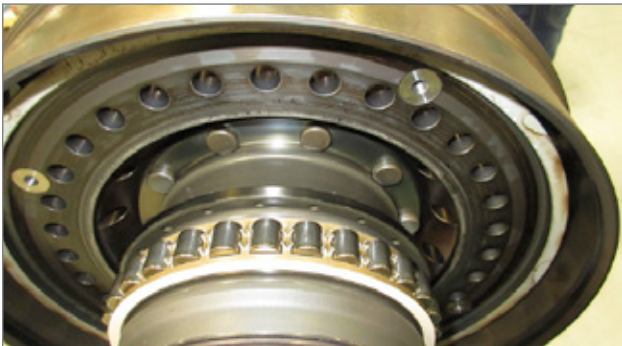
Bearing #4

Overall, the bearings, races, and compartments were very clean. Some of the bearings, however, did show some imperfections. For example, the #4 bearing's outer-race inner diameter showed some pitting that will require extra work.

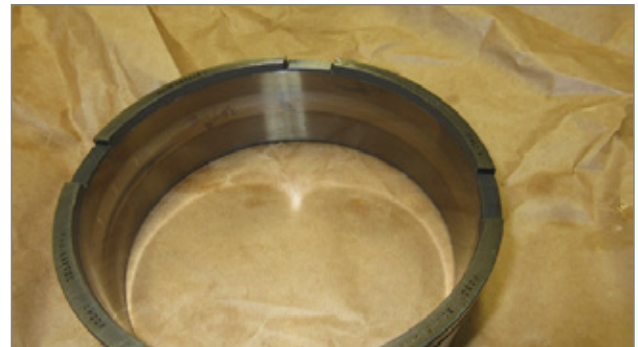
Bearing #5 outer-race ID

In contrast, the #5 bearing's outer-race inner diameter showed no signs of damage during the inspection when seen by the naked eye.
