Observing the significance and benefits of oil performance in reducing engine coking in CFM56-5B engines

Customer	Juneyao Airlines
Location	Shanghai, China
Industry	Commercial airline
Website	www.juneyaoair.com/en
Customer evaluation	Engine disassembly and inspection took place at repair and overhaul facility. Engine has more than 30,000 hours and 15,000 cycles using Eastman Turbo Oil 2197™.
Highlights	<ul style="list-style-type: none"> • Using Eastman turbo oil since EIS in December 2006 • 30,312:51 hours • 15,080 cycles
Contact	TurboOil@eastman.com

Juneyao Airlines elected to perform the oil systems review on a CFM56-5B4/P engine from an A320-200 aircraft. The engine was removed and sent to General Electric's Strother, Kansas, repair and overhaul facility for disassembly, inspection, and overhaul.

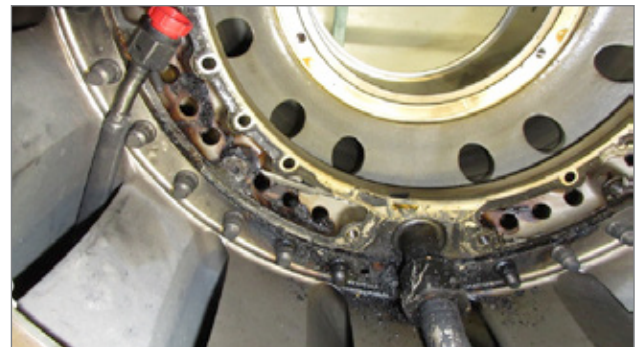
Rear sump

This inspection data further support the proven performance of Eastman Turbo Oil 2197. All inspected portions of the engine oil system were exceptionally clean and free of oil-derived deposits. Even though some of the tubes were unable to be fully accessed, the exposed parts of those tubes appeared clean and still in excellent condition. The results are substantiated by the images provided by both borescope and visual inspection, further supporting that Turbo Oil 2197 has a direct correlation with reducing engine coking compared to other turbine engine oils.
